Manhole Inspection Summary

Manhole # S29GG2002MH

Location Address: **8 BELLEMORE RD**

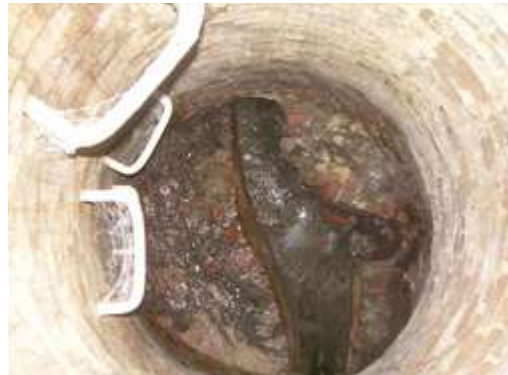
Top View

Evidence of surcharge - Bench debris.
Channel debris.

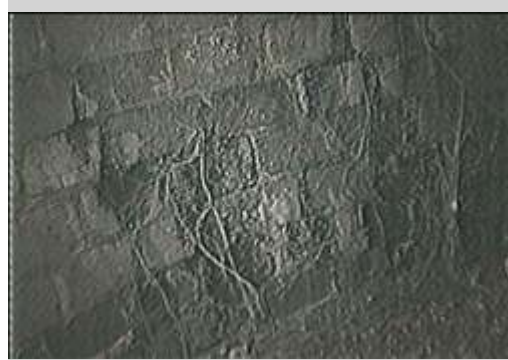
Defect

Barrel deterioration, root intrusion and infiltration. Bench root intrusion.

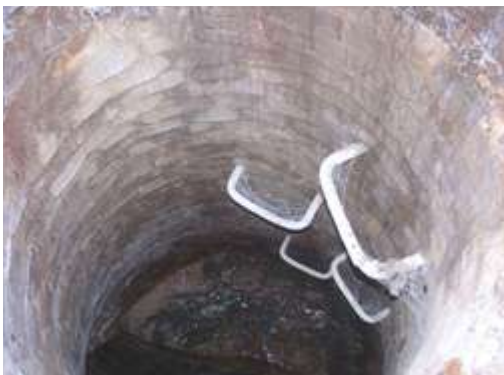
Defect

Adjustment deterioration and infiltration.
Corbel and Barrel infiltration - other side.

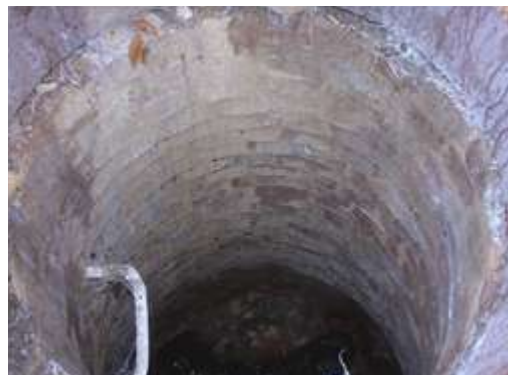
Defect

Adjustment deterioration and infiltration.
Corbel and Barrel infiltration.

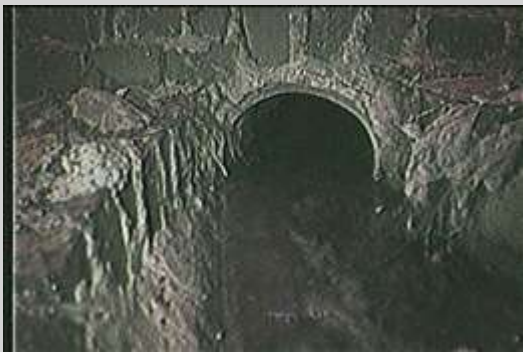
8 in. Circular Gravity Sewer Pipe Out @ 12 O'Clock

Deposits: ☐ None ☐ **Mud** ☐ Sludge ☒ **Debris** ☒ **Grease**

Infiltration: **Evidence** Pipe Seal Cond: **Cracked**

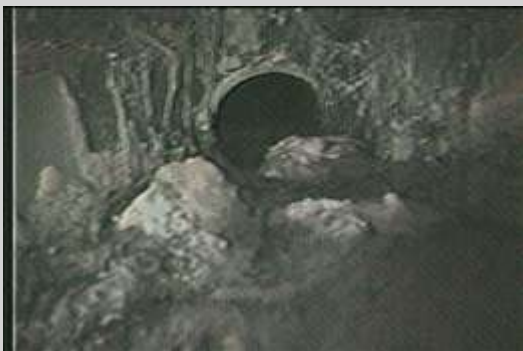
6 in. Circular Gravity Sewer Pipe In @ 3 O'Clock

Deposits: ☐ None ☒ **Mud** ☐ Sludge ☒ **Debris** ☒ **Grease**

Infiltration: **Evidence** Pipe Seal Cond: **Roots**

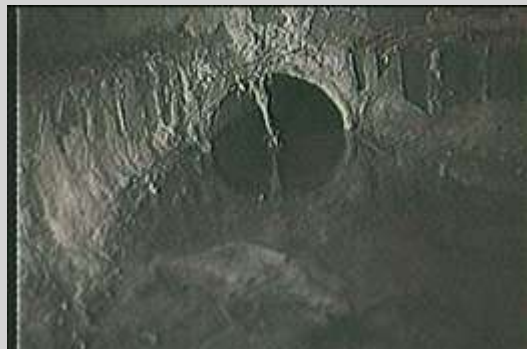
Pipe In @ 6 O'Clock

Deposits: ☐ None ☒ **Mud** ☐ Sludge ☒ **Debris** ☒ **Grease**

Infiltration: **Evidence**

Pipe Seal Cond: **Roots**
